The history, archaeology and material cultural of 105 Radar Station, Cox Peninsula, Northern Territory

TIM OWEN and SHELLEY JAMES

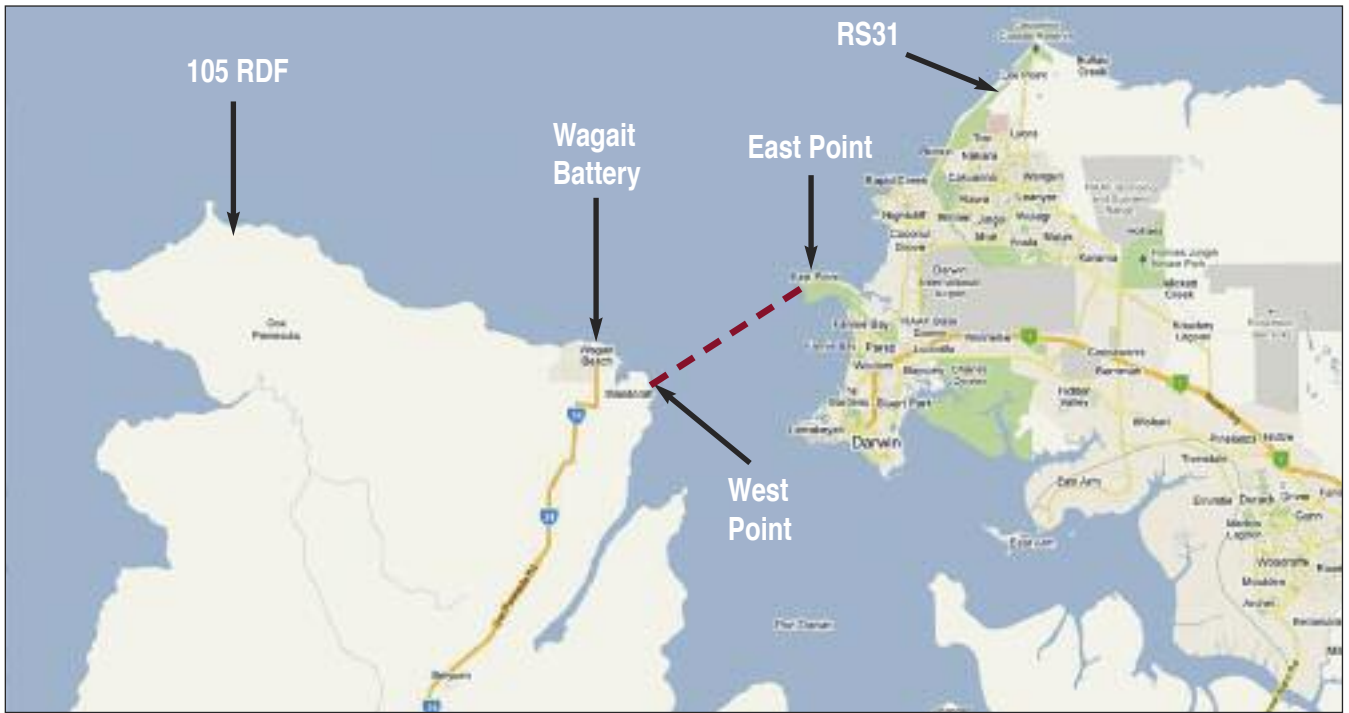
Figure 1: Key WWII Defences on the Cox Peninsula, East Point and RS31. Red line is the submarine net extending between East and West point (Image source: Google Maps).

The Cox Peninsula is located to the west of Darwin, approximately six kilometres across the bay. Three defensive positions were established on the peninsula, two obvious and one in some secrecy (Figure 1).

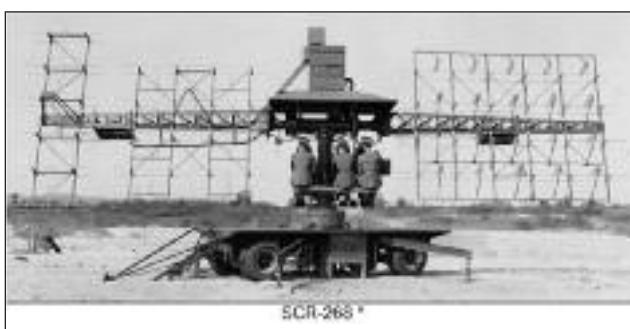
Figure 2: Exposed operators sat on a SCR 268 (NB this photograph is not of 105 Radar Station) (www.vectorsite.net).

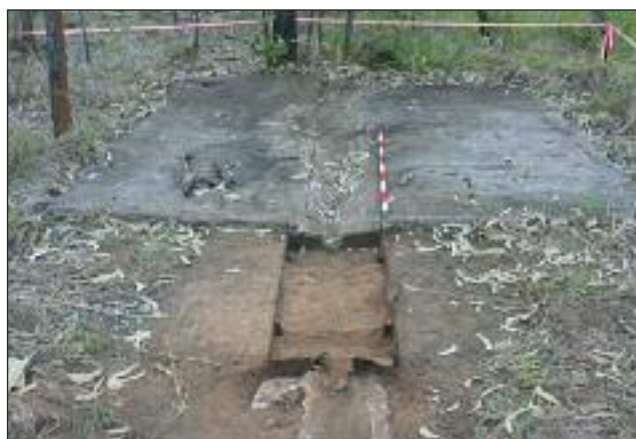
- Kitchen building (concrete slab D) – a square concrete slab (3.9m by 3.1) with a central drainage channel, which flowed south into a grey water system. The function of the slab is suggested to be the kitchen, where food preparation benches (with cut in half 44 gallon drums) would have been set over the drain (Figure 5);

Figure 5: Kitchen slab and grey water system (T. Owen).

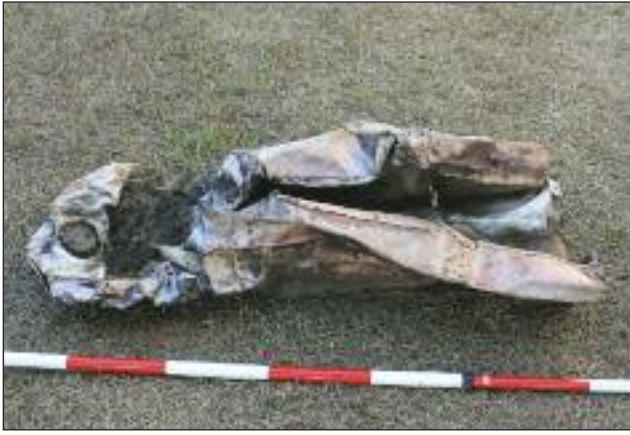
- RAN metal door sign and a metal tag – RAN door sign was found on the mess slab, the metal tag was stamped "James Tombs, Birmingham, England"; and
- A fuel 'drop tank' (Figure 7) and a cylinder block both from a Japanese Zero plane – fuel tanks were dumped by the Japanese prior to the commencement of bombing runs. These frequently washed up on Darwin's beaches and were used by the men of 105 RDF as canoes enabling them to paddle around the bay.

Figure 7: Crumpled drop tank from a Japanese zero (T. Owen).
